Servicing Midea Heat Pumps

280: Removing Upper Casing

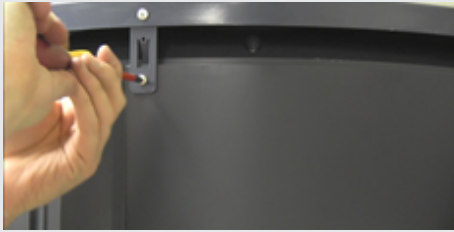
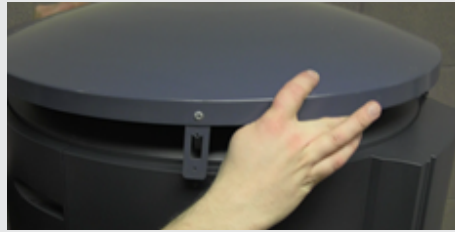
Start by removing the rain shield (where applicable) by removing the fasteners at the four tab locations and then lifting the shield up and putting aside.

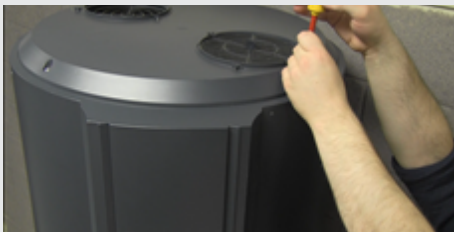
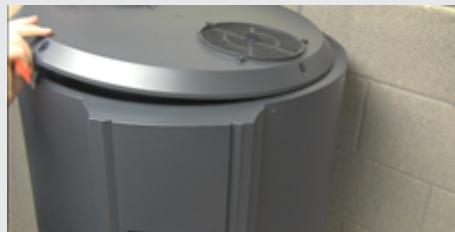
Then proceed to remove the top plate by removing the additional 4 fasteners and again simply lift up & put aside.

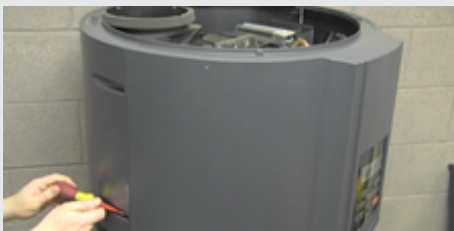
Then release the four fasteners, two either side holding the front casing on.

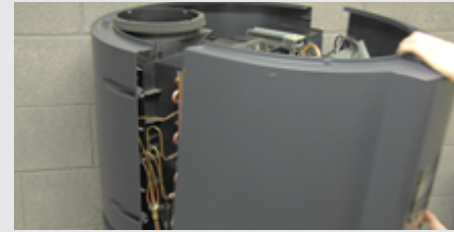
Once the screws are removed carefully pull the front casing away enough to access the controller connector and release. Then put the front casing aside.

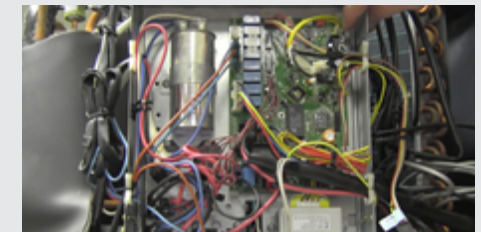
At this time it is also recommended to open the electrical compartment which is located directly behind the control panel. To access simply remove the compartment panel by removing the two lower screws.

Then simply slide the panel down and then pull away to reveal the PCB and other electrical connections.

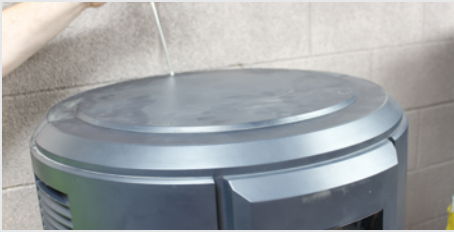
Remove the screw from the top cover (on the top face at the rear), then rotate the top cover counter-clockwise to release

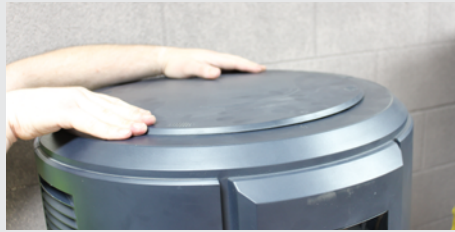
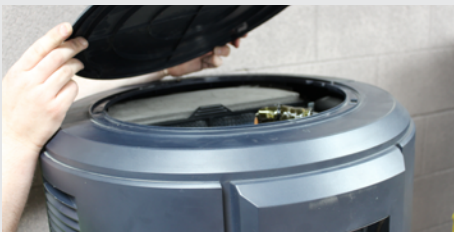
Then lift the top cover up and put aside. Then release the four fasteners, two either side holding the front casing on.

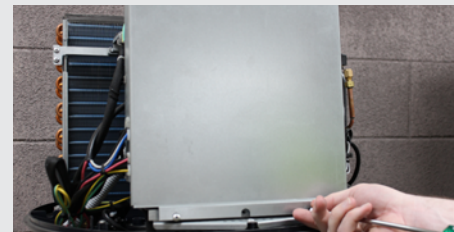
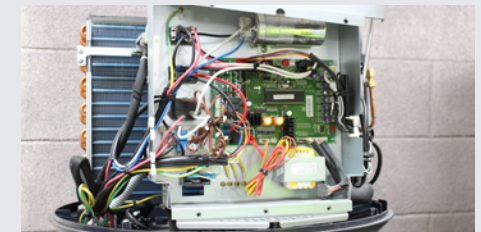
Once the screws are removed carefully pull the front casing away enough to access the controller connector and release. Then put the front casing aside.

At this time it is also recommended to open the electrical compartment which is located directly behind the control panel. To access simply remove the compartment panel by removing the two lower screws & two upper screws.

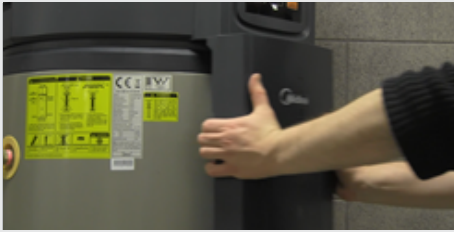
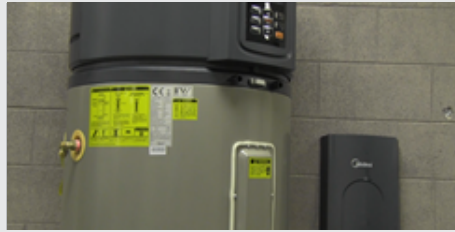
If the controller is indicating an E0 error, then there is an issue with the upper tank sensor. To access the tank sensors, start by removing the front fascia at the front of the unit. Simply grip the fascia from either side and firmly pull the whole piece away from the tank to release the three holding magnets from the tank body. Then put the fascia aside.

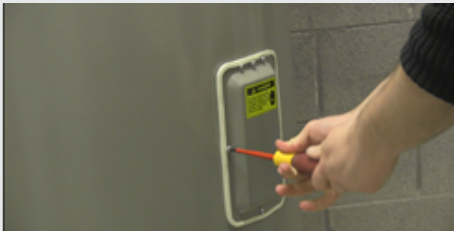
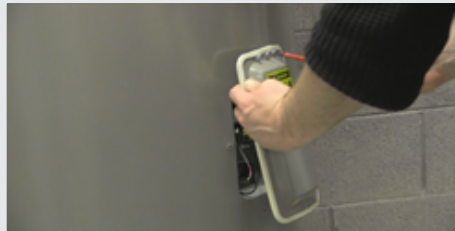
Remove the lower electrical cover by removing the array of screws and put cover and fasteners aside.

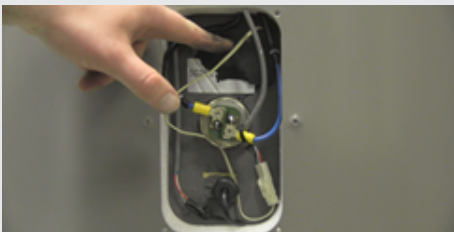
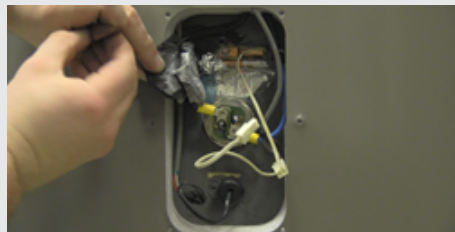
If you are presented with an error code of E0, then this relates to the upper tank sensor (referred to as Sensor T5U). To check the correct operation of the upper tank sensor, locate the sensor behind the foam insulation.

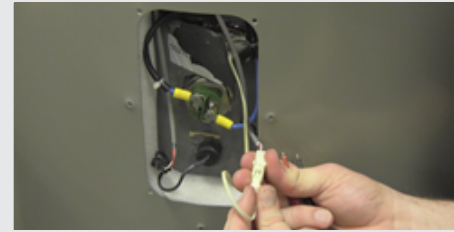
Simply release the corresponding connector and test for the appropriate resistance using a multimeter. The resistance reading will vary depending on the temperature within the tank so you will need to confirm the correct reading by referring to the resistance chart. (Click to open chart). If you are receiving a suitable reading, reconnect the connector and ensure this is securely in place.

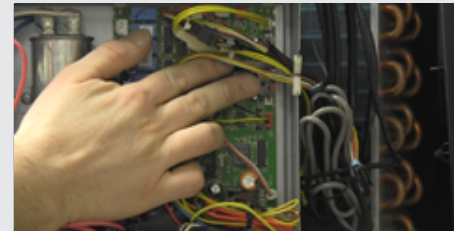
If you are not receiving a suitable reading, access the PCB board and check the corresponding connector is securely connected to the PCB in socket T5U. Once the connector has been checked, retest resistance. If this continues to provide an unsatisfactory reading, remove the sensor by disconnecting the corresponding lead & releasing the nut holding the sensor in place. Remove the sensor off the stud and replace with a new sensor and lead.

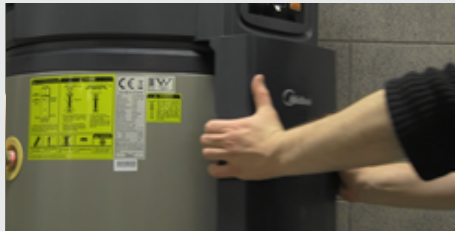
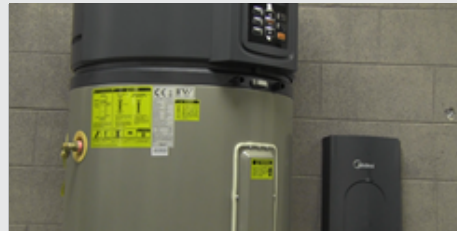
If the controller is indicating an error of E1, then there is an issue with the lower tank sensor. To access the tank sensors, start by removing the front fascia at the front of the unit. Simply grip the fascia from either side and firmly pull the whole piece away from the tank to release the three holding magnets from the tank body. Then put the fascia aside.

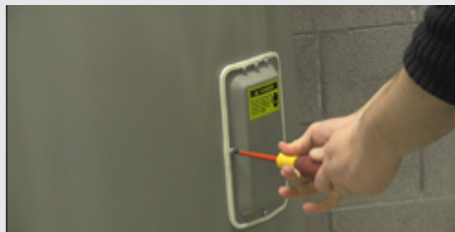
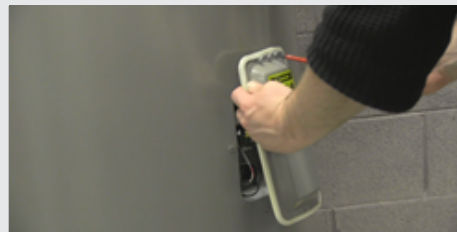
Remove the lower electrical cover by removing the array of screws and put cover and fasteners aside.

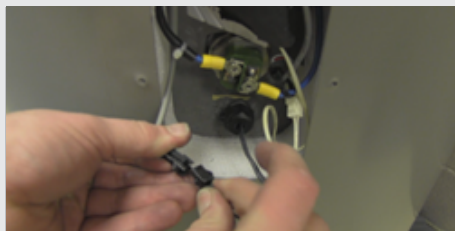
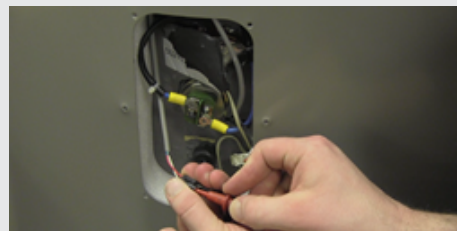
To check the correct operation of the lower tank sensor, simply release the corresponding connector and test for the appropriate resistance using a multimeter. The resistance reading will vary depending on the temperature within the tank so you will need to confirm the correct reading by referring to the resistance chart (Click to Open Chart) If you are receiving the correct reading, reconnect the connector and ensure this is securely in place.

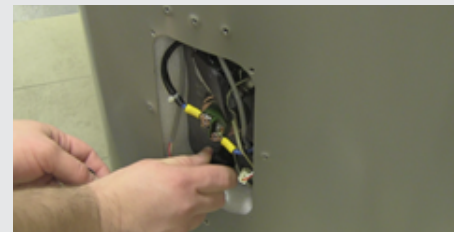
If this continues to provide an unsatisfactory reading, remove the sensor by turning counter clockwise and pulling directly away from the tank.

Be careful as probe will be covered in heat paste.

Then simply replace with new sensor, screw securely back into place and reconnect to the mating connector. After a sensor has been replaced or electrical connectors have been resealed, restart the unit and check that the error has cleared.

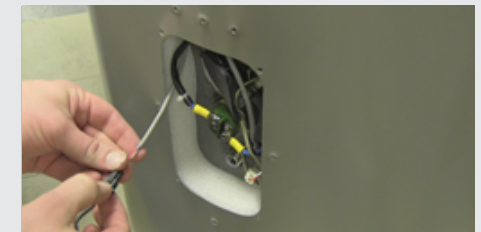
If you are not receiving a suitable reading, access the PCB board and check the corresponding connector is securely connected to the PCB in socket T5L. Once the connector has been checked, retest resistance.

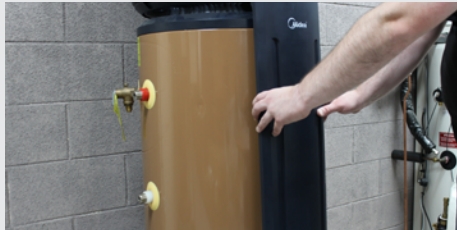
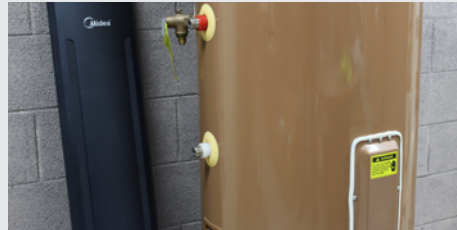
If the controller is indicating an error of E1, then there is an issue with the tank sensor. To access the tank sensors, start by removing the front fascia at the front of the unit. Simply grip the fascia from either side and firmly lift vertically to release the pins at the top and the holding bracket at the bottom, then pull the whole away from the tank body. Then put the fascia aside.

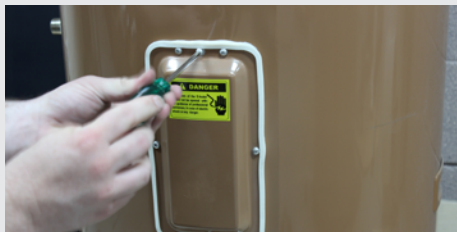
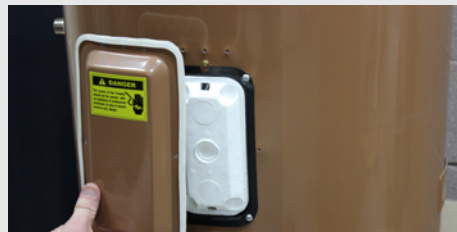
Remove the electrical cover by removing the array of screws and put cover and fasteners aside.

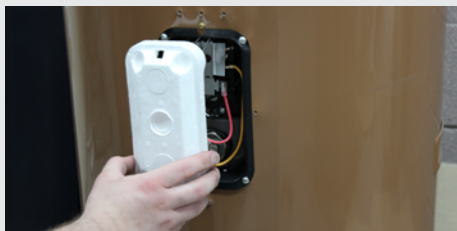
Then remove the foam insulation and put aside.

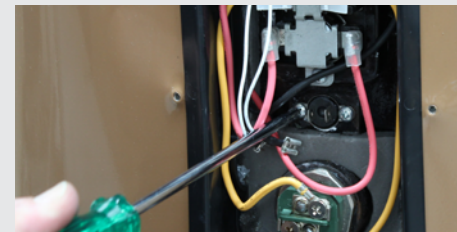
If this continues to provide an unsatisfactory reading, remove the sensor by removing both electrical connectors and removing the two screws. Then simply removed the sensor and bracket.

Be careful as rear of the sensor will be covered in heat paste.

Then simply replace with new sensor, place bracket over the top and screw securely back into place before reconnecting the two electrical connectors. After a sensor has been replaced or electrical connectors have been reseated, restart the unit and check that the error has cleared.

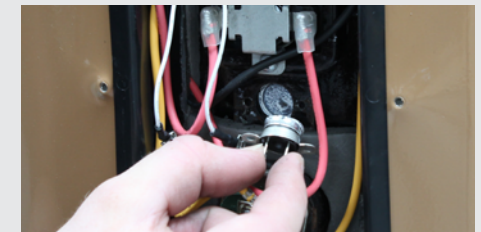
If you are not receiving a suitable reading, access the PCB board and check the corresponding connector is securely connected to the PCB in socket T5. Once the connector has been checked, retest resistance.

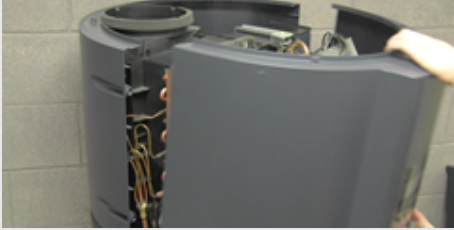
If the controller is indicating an error of E2, then there is an issue with the connection between the display PCB and the mother PCB.

To access both PCBs we need to remove the upper front casing (refer to separate instruction).

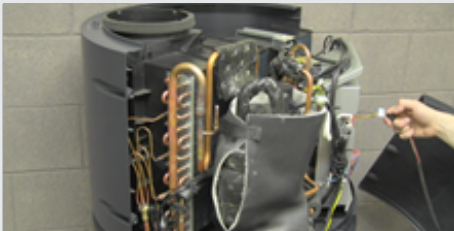
Check the connection between the display PCB and the mother PCB for any loose connections or cable damage.

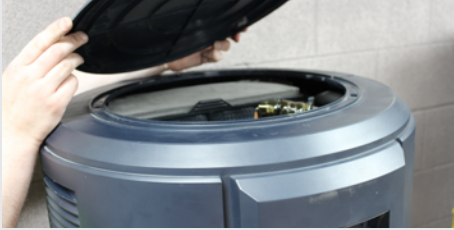
If the controller is indicating an error of E2, then there is an issue with the connection between the display PCB and the mother PCB.

To access both PCBs we need to remove the upper front casing (refer to separate instruction).

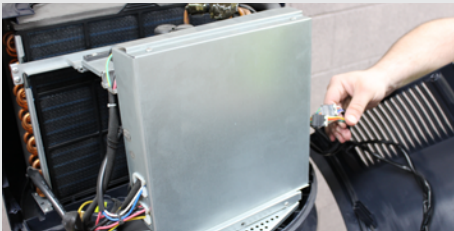
Check the connection between the display PCB and the mother PCB for any loose connections or cable damage.

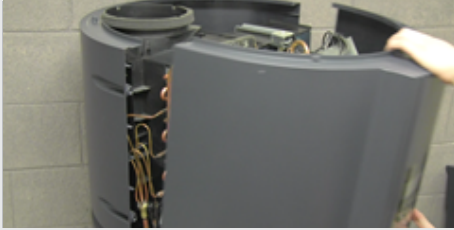
If the controller indicates an E4 error code, then there is an issue with the Evaporator Temperature Sensor (T3 Sensor).
To access the evaporator temp sensor, we need to remove the upper front casing (refer to separate instruction).
The Evaporative Temp Sensor is located on the left hand side of the evaporator

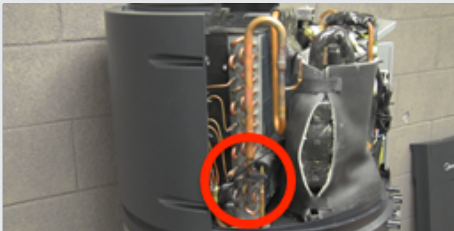
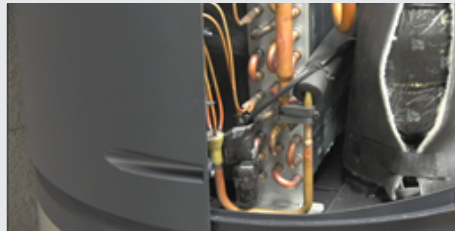
To access the sensor, cut the cable tie and carefully remove the insulation.

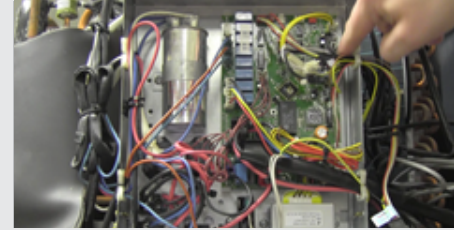
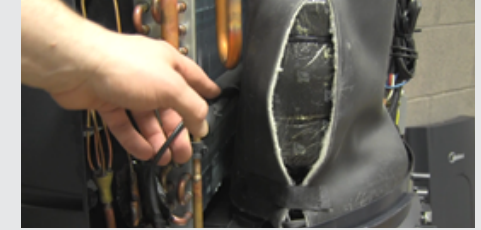
Remove the sensor from its container and inspect for any visual damage and check that the corresponding connector to the PCB board is securely seated.

If it appears the sensor needs replacing, disconnect the T3 connector at the PCB location and feed the cable back behind the electrical compartment and the compressor to the sensor location.

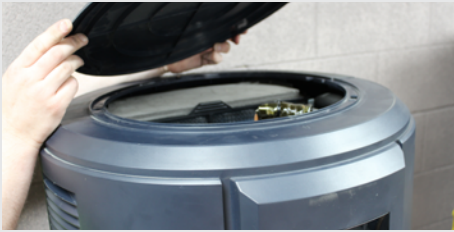
If the controller indicates an E4 error code, then there is an issue with the Evaporator Temperature Sensor (T3 Sensor). To access the evaporator temp sensor, we need to remove the upper front casing (refer to separate instruction).

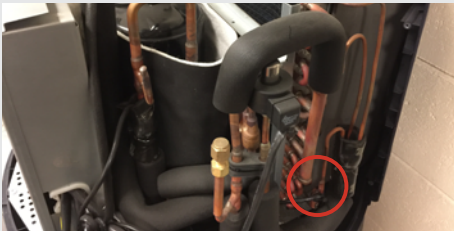
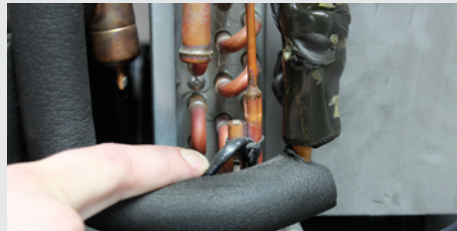
The Evaporative Temp Sensor is located on the right hand side of the evaporator.

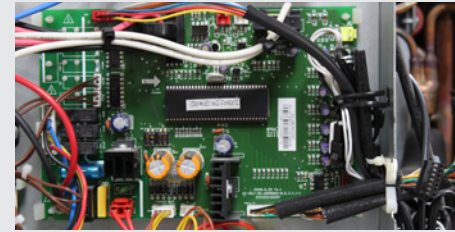
To access the sensor, cut the cable tie. Remove the sensor from its container and inspect for any visual damage and check that the corresponding connector to the PCB board is securely seated.

If it appears the sensor needs replacing, disconnect the T3 connector at the PCB location and feed the cable through to the sensor location.

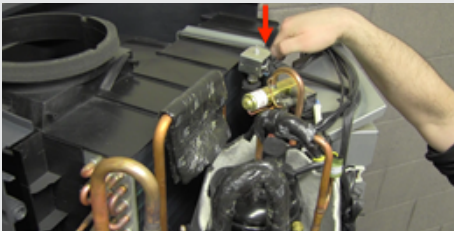
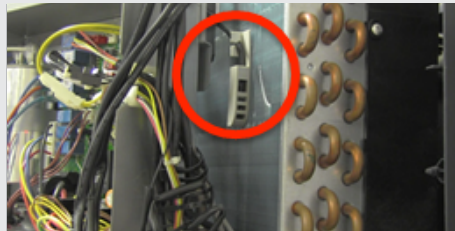
The Ambient Temperature sensor is located on the right hand side fitted to the face of the evaporator.

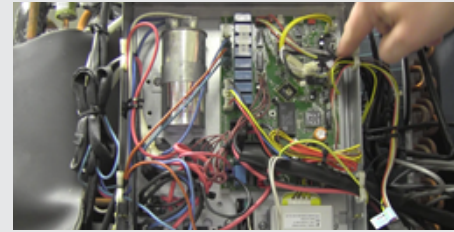
To remove sensor, simply grip the plastic holder and pull directly out from the evaporator fins. Inspect for any visual damage and check that the corresponding connector is securely seated in the T4 socket on the PCB.

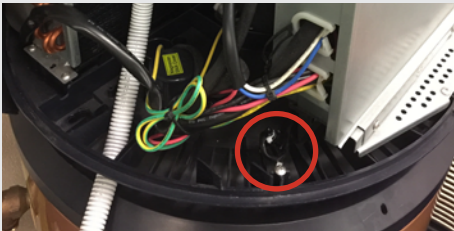
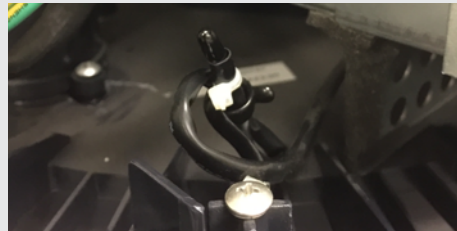
The Ambient Temperature sensor is located on the left hand side fitted to the body of the heat pump.

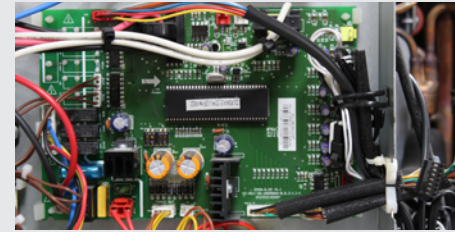
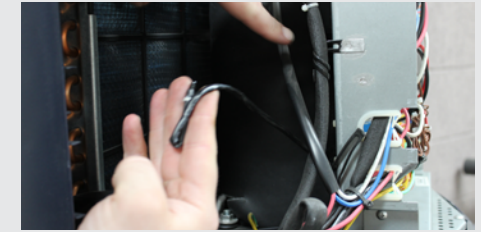
To remove sensor, simply unwind the holding clip / wire until the sensor is clear. Inspect for any visual damage and check that the corresponding connector is securely seated in the T4 socket on the PCB.

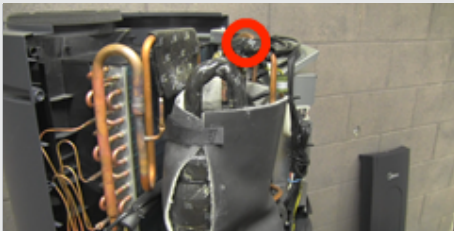
The Compressor Discharge Temp Sensor is located above the compressor at the compressors outlet pipe

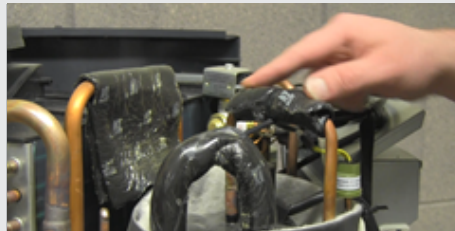
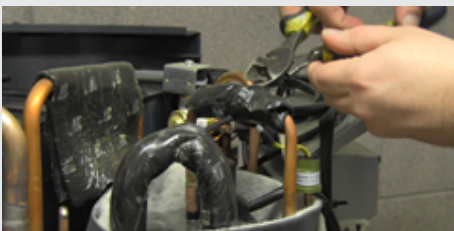
To access the sensor, cut the cable tie and carefully remove the insulation.

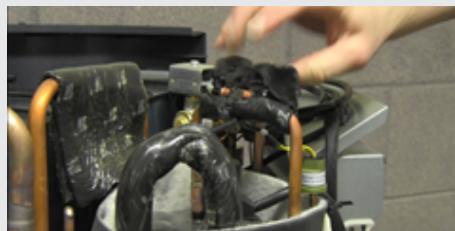
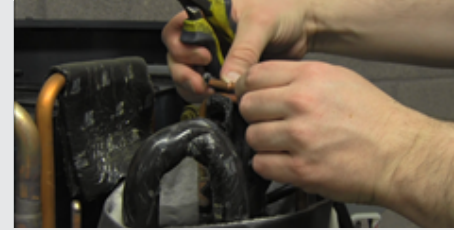
Continue by removing the cable tie holding the sensor in place and then remove the sensor. Inspect for any visual damage to the sensor and its lead and check that the corresponding connector is securely seated in the TP socket on the PCB.

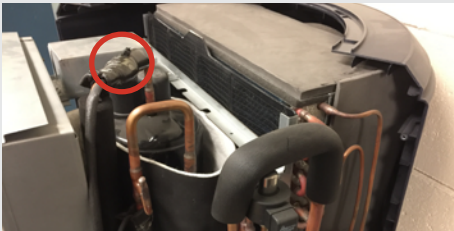
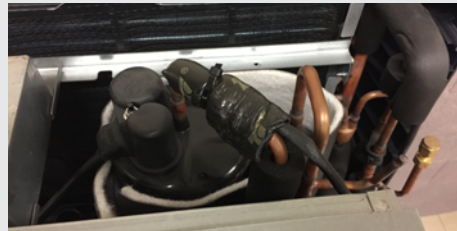
The Compressor Discharge Temp Sensor is located above the compressor at the compressors outlet pipe

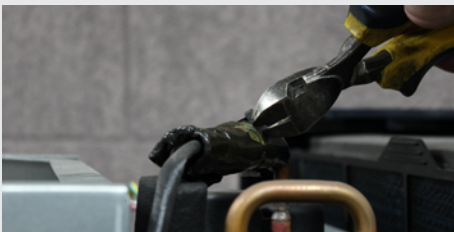
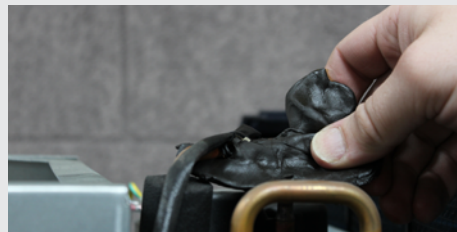
To access the sensor, cut the cable tie and carefully remove the insulation.

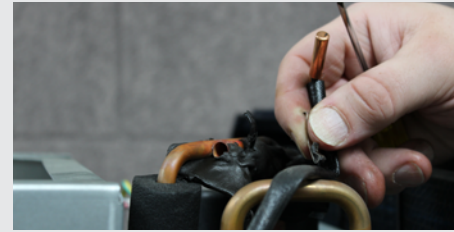
Continue by removing the cable tie holding the sensor in place and then remove the sensor. Inspect for any visual damage to the sensor and its lead and check that the corresponding connector is securely seated in the TP socket on the PCB.

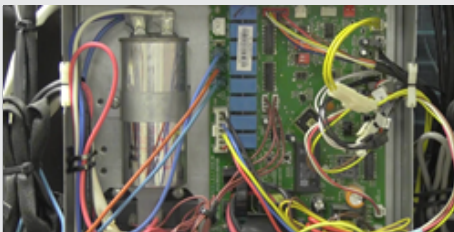
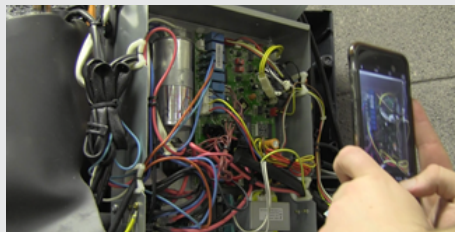
If the E8 error is presenting on start up, then we need to inspect a few items within the electrical compartment. Firstly check that all connectors are securely seated in their corresponding socket. Perform an inspection across the electrical compartment checking for any damage or signs of moisture.

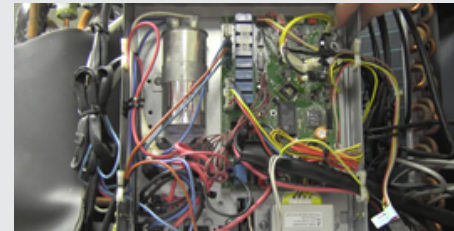
To replace, leave all connections in position and remove the current board by releasing the

plastic clips at the top and bottom location and move to the side, refit the new board into position and then proceed to disconnect and then reconnect each connector one by one to ensure that each one is connected to the correct location.

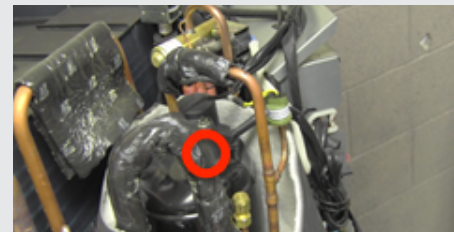
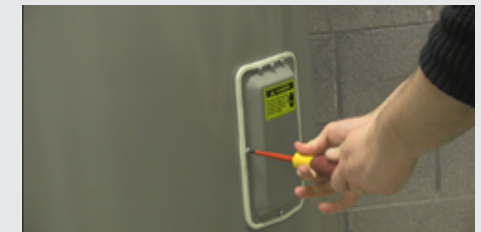
Now if the error presents approx. 3 mins after start up then we need to check over the compressor.

Locate the compressor and its electrical connections cover. Remove the holding nut and then the cover to reveal the electrical connections. Test the connections and resolve where possible. If the compressor is deemed to have failed contact Chromagen for further advice.

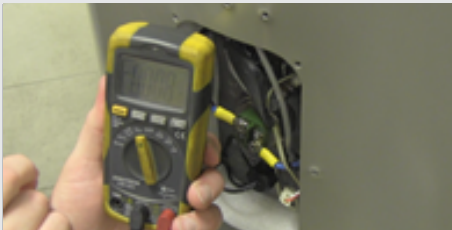
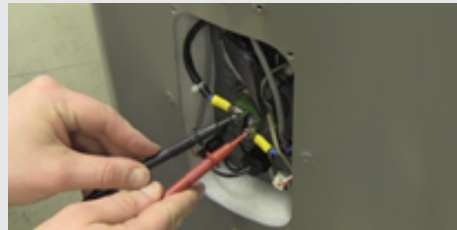
Now if the E8 error presents once the unit enters E-heater mode, we need to check the element. Proceed to access the element compartment located in the lower compartment under the front fascia cover. Remove the lower electrical cover by removing the array of screws and put cover and fasteners aside.

With power activated to the unit, carefully test the element is receiving 240 Volts with a multimeter by placing each of the prongs on the two terminals. If 240 volts is evident then there appears to be an issue with the element. If this is the case isolate power to unit and proceed to replace the element.

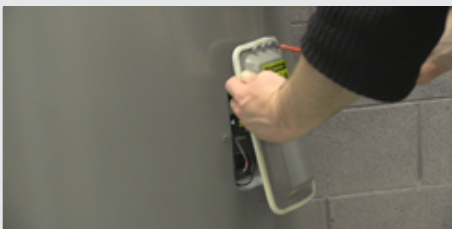
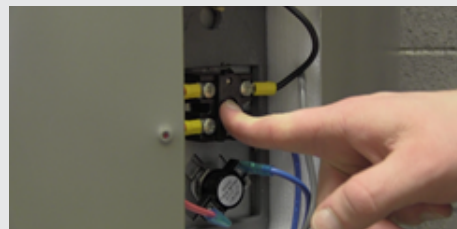
If 240 volts is not evident, we need to test all the corresponding connections back to the PCB to locate where the error exists.

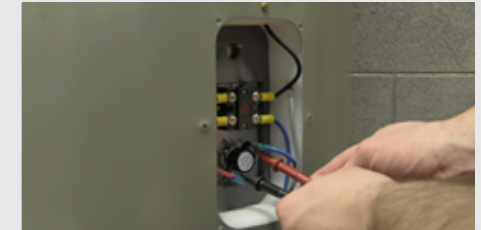
So firstly we need remove the upper tank compartment. Then check that the manual thermostat hasn't been tripped. If tripped, the red button will protrude past the thermostat and will need to be manually reset by carefully pushing the red button.

If the manual thermostat has not been tripped, then we need to proceed to test the automatic thermostat for 240 volt supply. Again with power activated to the unit, carefully test the automatic thermostat. If the automatic thermostat is showing 240 volt supply, then the issue lies between the automatic thermostat and the element. If the automatic thermostat shows no voltage then continue to test up the line, checking the manual thermostat for correct voltage.

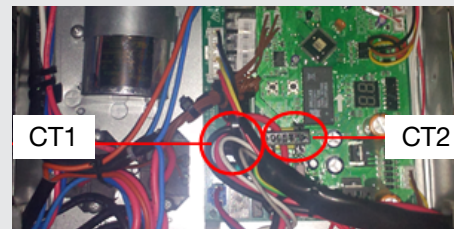
If there is still no voltage at the manual thermostat then check the UE connector within the electrical compartment is providing power.

If E8 turn up straight away after HP power reset, take the power cable off from the current induction coil CT1 (do not let CT1 coil detect any current), if it still reports E8, then replace PCB. If it doesn't report E8, it means the PCB is fine.

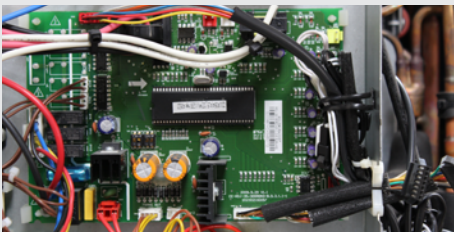
If the E8 error is presenting on start up, then we need to inspect a few items within the electrical compartment. Firstly check that all connectors are securely seated in their corresponding socket. Perform an inspection across the electrical compartment checking for any damage or signs of moisture.

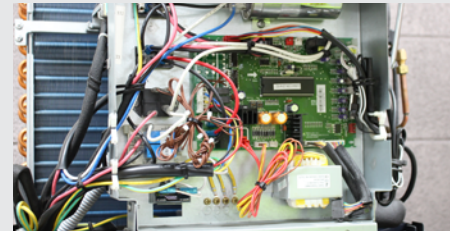
To replace, leave all connections in position and remove the current board by releasing the plastic clips at the top and bottom location and move to the side, refit the new board into position and then proceed to disconnect and then reconnect each connector one by one to ensure that each one is connected to the correct location.

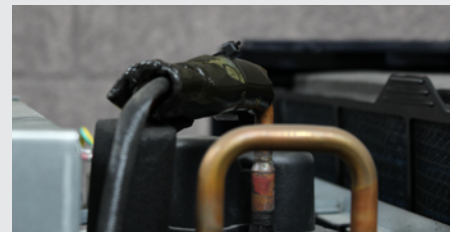
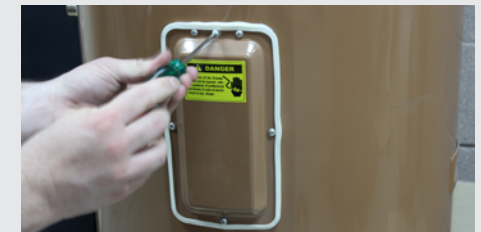
Now if the error presents approx. 3 mins after start up then we need to check over the compressor.

Locate the compressor and its electrical connections cover. Remove the holding nut and then the cover to reveal the electrical connections. Test the connections and resolve where possible. If the compressor is deemed to have failed contact Chromagen for further advice.

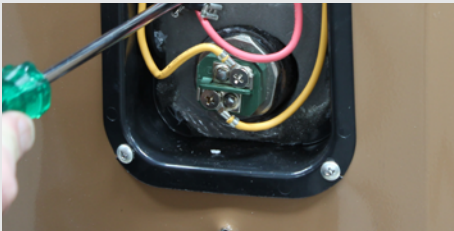
With power activated to the unit, carefully test the element is receiving 240 Volts with a multimeter by placing each of the prongs on the two terminals. If 240 volts is evident then there appears to be an issue with the element. If this is the case isolate power to unit and proceed to replace the element.

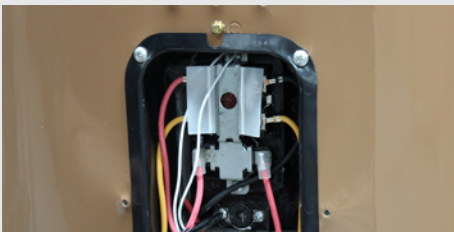
If 240 volts is not evident, we need to test all the corresponding connections back to the PCB to locate where the error exists. Proceed to carefully test the thermostat. If the thermostat is showing 240 volt supply, then the issue lies between the automatic thermostat and the element. If the automatic thermostat shows no voltage then continue to test up the line for correct voltage.

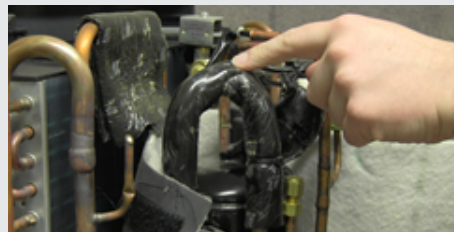
The Compressor Suction Temp Sensor is located on the inlet pipe to the compressor. To access we need to remove the insulation of the compressor by removing the two Velcro tabs.

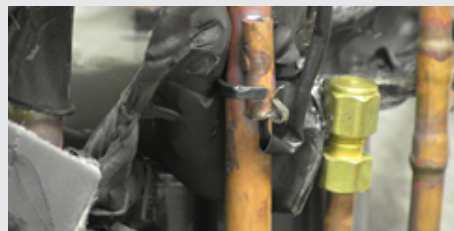
Then to uncover the sensor we need to remove the cable tie and peel back the insulation material. Then to release the sensor, cut the cable tie and gently pull down out of its container.

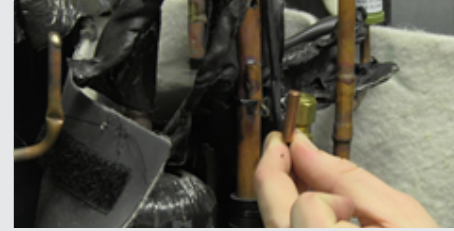
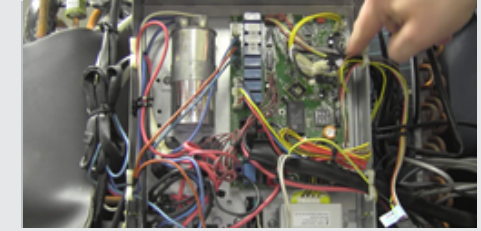
Inspect for any visual damage to the sensor and its lead and check that the corresponding connector is securely seated in the TH socket on the PCB. Once a visual inspection is deemed OK and the connector has been resealed, restart the unit and see if the error has cleared.

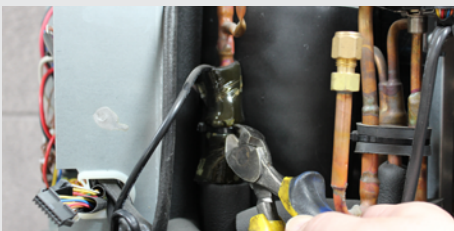
The Compressor Suction Temp Sensor is located on the inlet pipe to the compressor

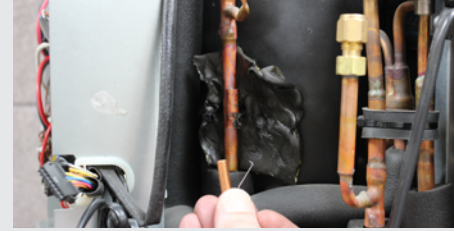
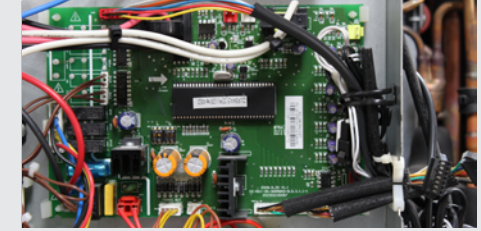
Then to release the sensor, cut the cable tie and gently pull down out of its container. Inspect for any visual damage to the sensor and its lead and check that the corresponding connector is securely seated in the TH socket on the PCB. Once a visual inspection is deemed OK and the connector has been resealed, restart the unit and see if the error has cleared.

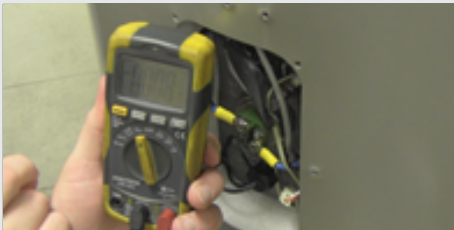
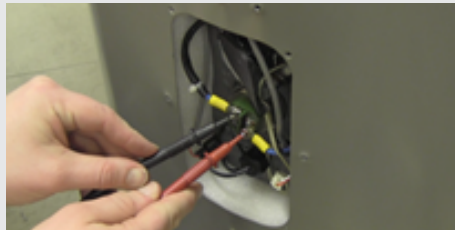
With power activated to the unit, carefully test the element is receiving 240 Volts with a multimeter by placing each of the prongs on the two terminals. If 240 volts is evident then there appears to be an issue with the element. If this is the case isolate power to unit and proceed to replace the element.

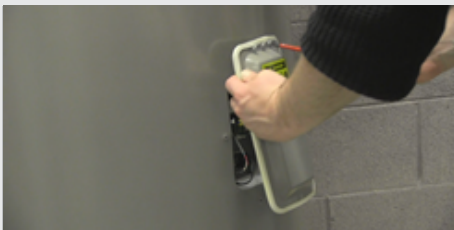
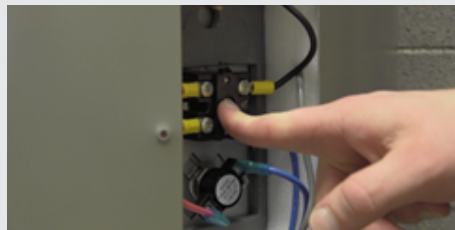
If 240 volts is not evident, we need to test all the corresponding connections back to the PCB to locate where the error exists.

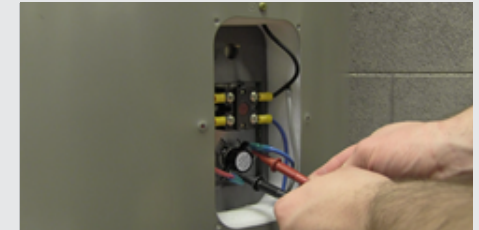
If the manual thermostat has not been tripped, then we need to proceed to test the automatic thermostat for 240 volt supply. Again with power activated to the unit, carefully test the automatic thermostat. If the automatic thermostat is showing 240 volt supply, then the issue lies between the automatic thermostat and the element. If the automatic thermostat shows no voltage then continue to test up the line, checking the manual thermostat for correct voltage.

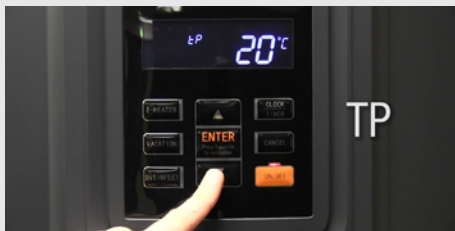
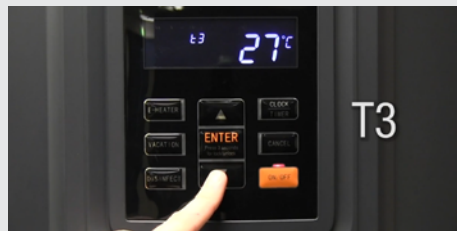
When the P3 error occurs we need to check the sensors are reading the correct temperature. To check the temperature readings we need to enter "query" mode. To do this simply press the E-heater and the disinfect button simultaneously for 1 sec.

Once mode is entered we can scroll through the running parameters including the temperatures for both the Compressor discharge sensor (TP) and the evaporator temperature sensor (T3)
(Record both temperatures down)

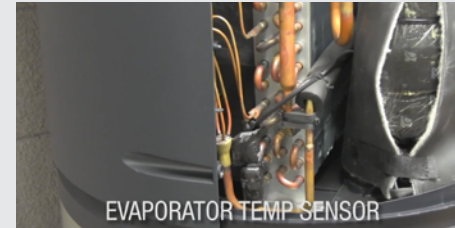
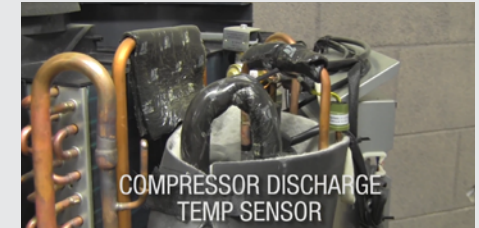
If the parameters on screen confirm there is a difference of less than 10 degrees, then we need to perform a manual check, testing the temperature of each location. If the manual readings support both of the on screen readings then it would appear that there is a compressor issue. If one or both manual readings are significantly different then the corresponding sensor may need to be replaced. (Refer to the relevant instruction)

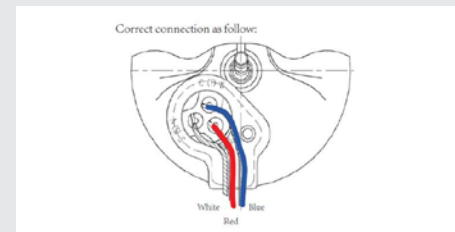
If both sensors are fine, restart the unit and check if the compressor starts to run. If the compressor is not running, check the compressor resistance, along with the compressor's wiring connection (as shown above), and check whether power is evident in the compressor terminal,

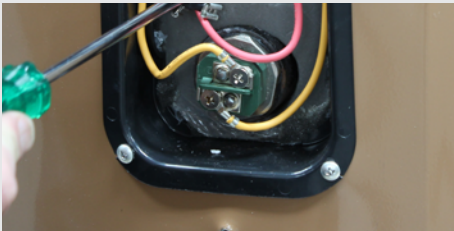
With power activated to the unit, carefully test the element is receiving 240 Volts with a multimeter by placing each of the prongs on the two terminals. If 240 volts is evident then there appears to be an issue with the element. If this is the case isolate power to unit and proceed to replace the element.

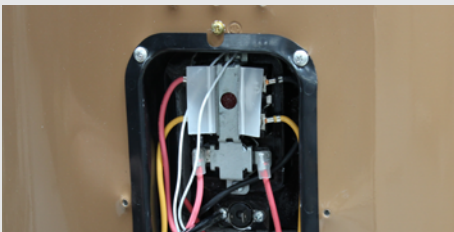
If 240 volts is not evident, we need to test all the corresponding connections back to the PCB to locate where the error exists. Proceed to carefully test the thermostat. If the thermostat is showing 240 volt supply, then the issue lies between the thermostat and the element. If the thermostat shows no voltage then continue to test up the line for correct voltage.
